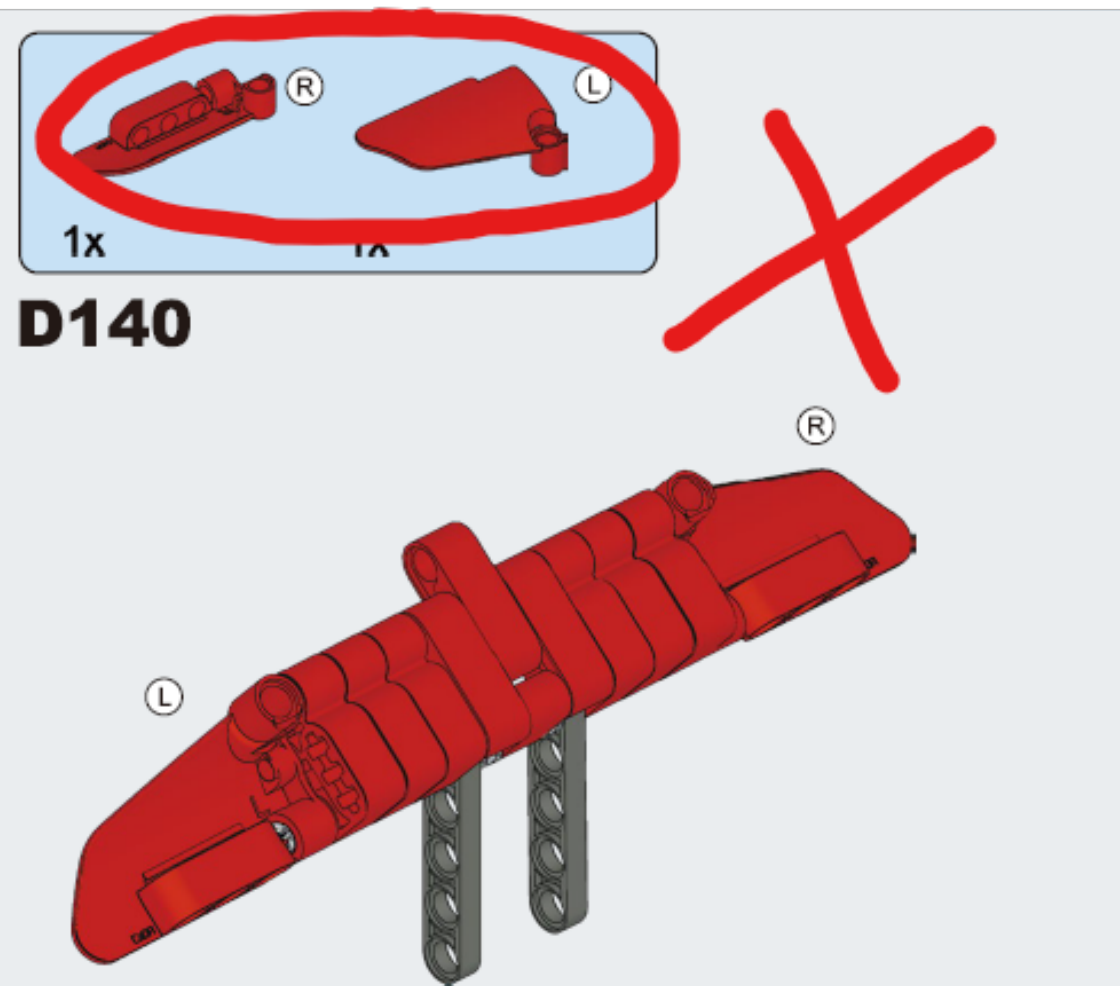
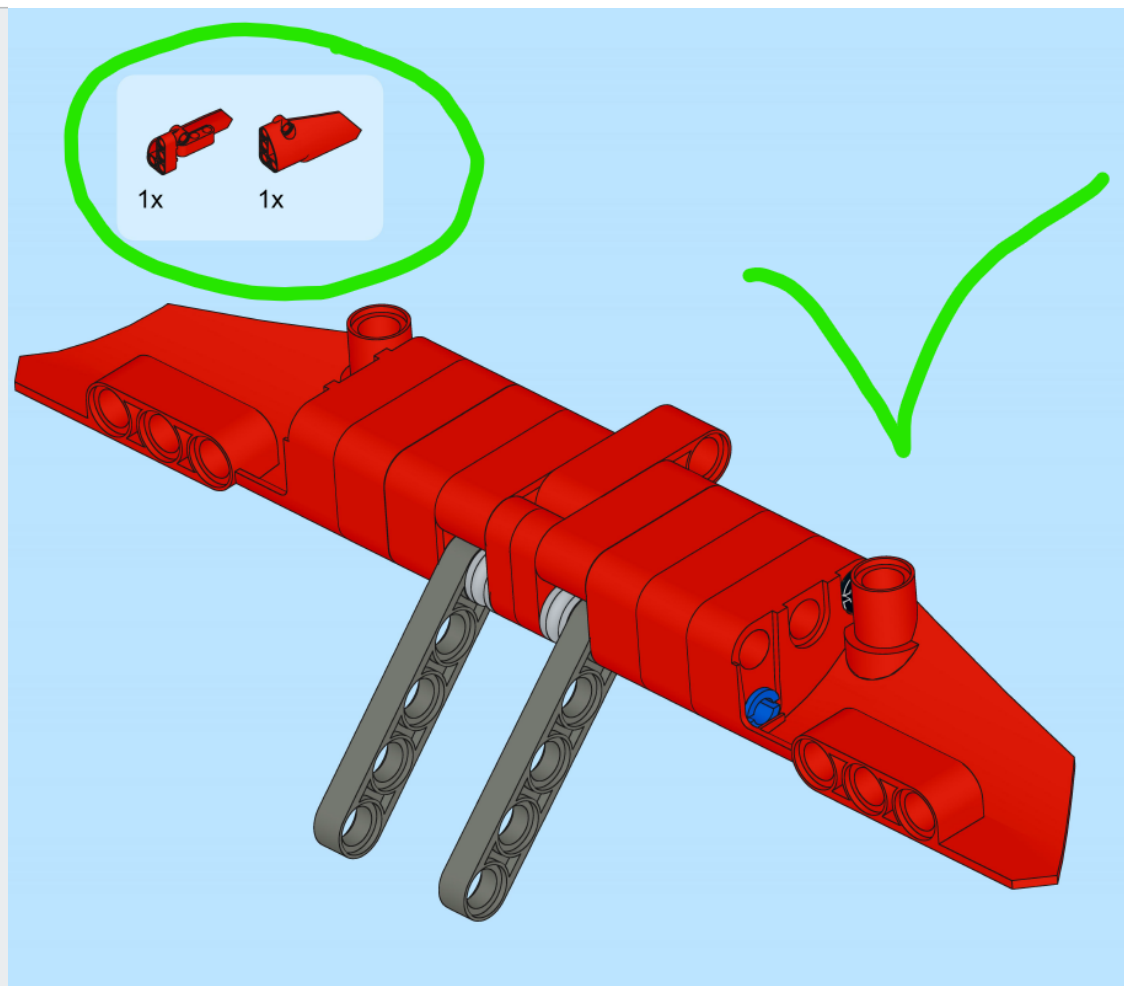
Use standard #3 / #4 panels (part number 64683)

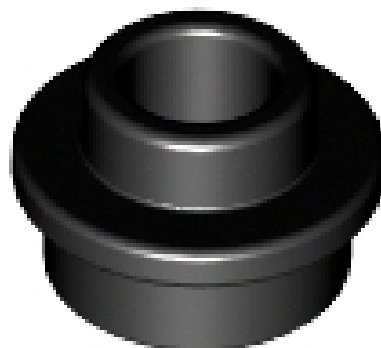
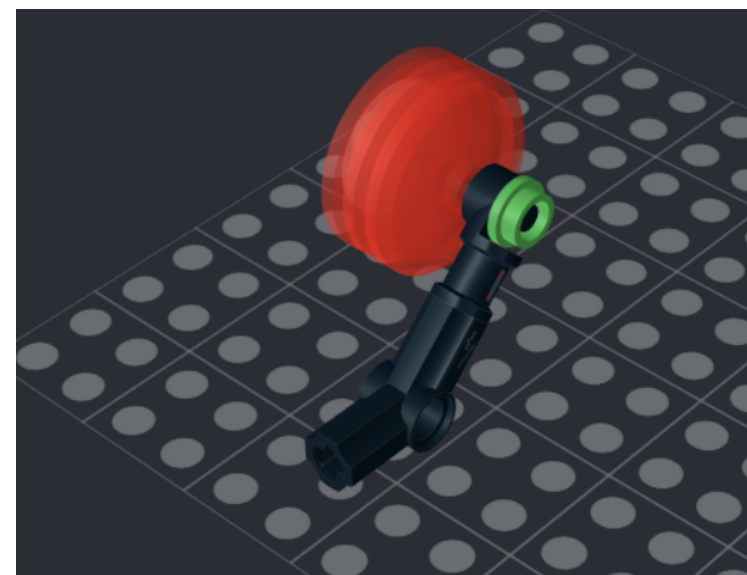
Reinforce tail light using:

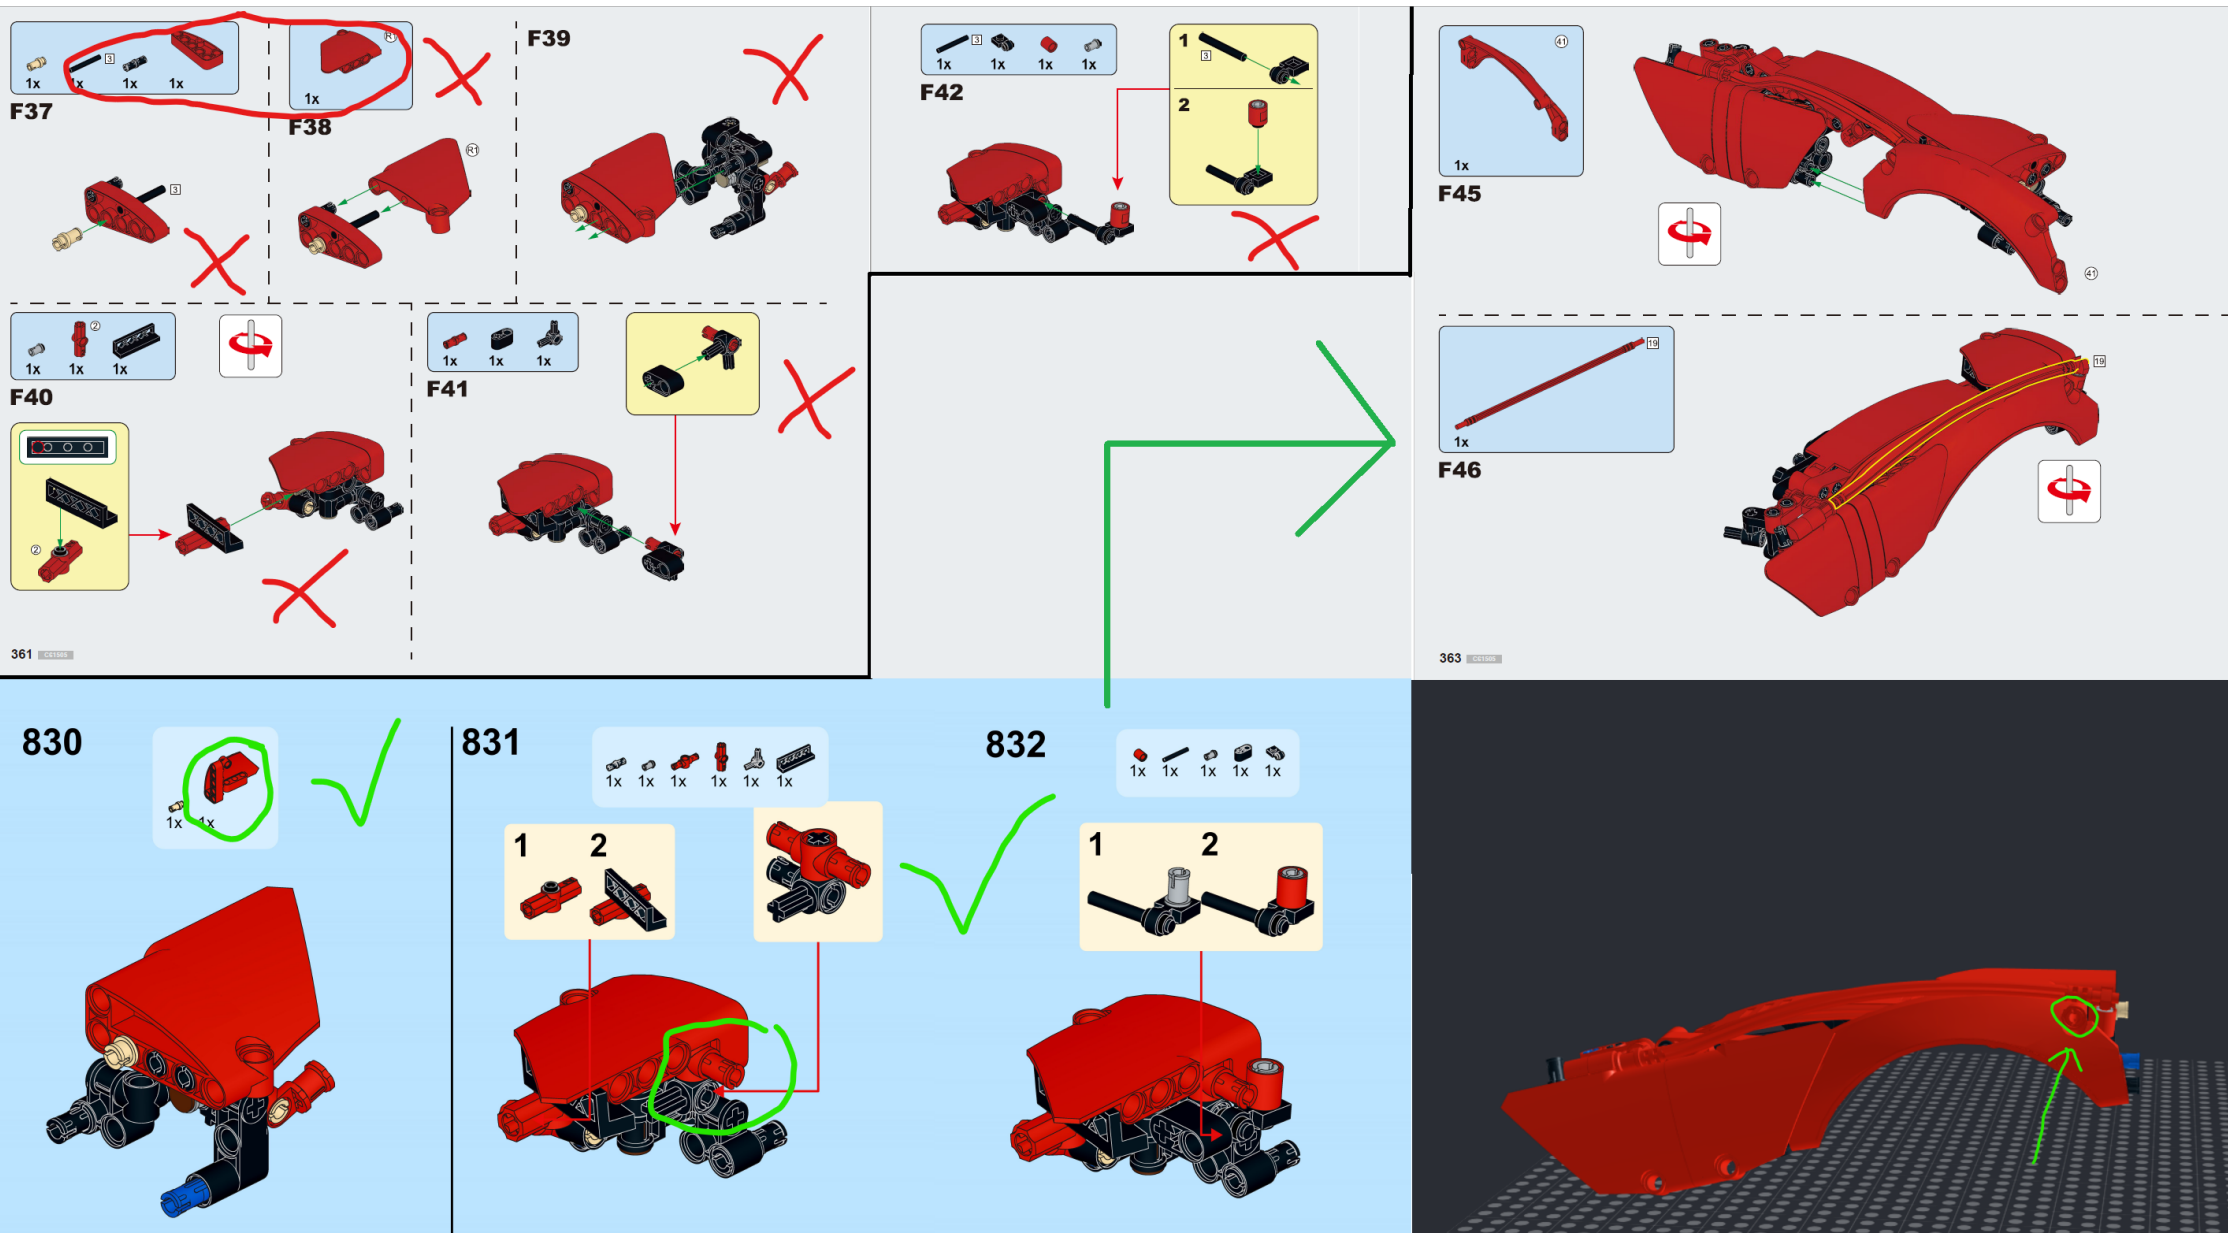
The following is NOT an instruction error but an improvement to reinforce the engine cover. It requires using a standard #13/ #14 panel instead of the CaDa version of it, found in the set.

After completing the steps below, the wheelarch panel (part 69911) should now also be connected with its right pinhole, as indicated in the right bottom picture.
